Home Inspection Report

1234 Sample Inspection Street
Better City, North Carolina 27215

Date of Inspection: Saturday, February 28, 2015

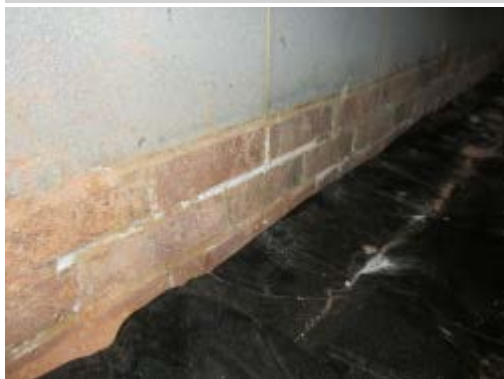
(A1 - 1.1) Main House

Efflorescence (salt stains) was noted on the foundation walls. The stains indicate that the foundation was been cyclically wet and dry. Water penetration into the foundation area can result in structural damage and undesirable environmental conditions. Water in the foundation area indicates an absent or damaged waterproofing and foundation drain systems. Repairs are needed to prevent water penetration. A general contractor should be consulted for further evaluation to determine the source of the moisture and to make necessary repairs.

Efflorescence (salt stains) was noted on the foundation walls. The stains indicate that the foundation was been cyclically wet and dry.

Water penetration into the foundation area can result in structural damage and undesirable environmental conditions. Water in the foundation area indicates an absent or damaged waterproofing and foundation drain systems. Repairs are needed to prevent water penetration. A general contractor should be consulted for further evaluation to determine the source of the moisture and to make necessary repairs.

Refer to the exterior section of the report concerning the lot grading.

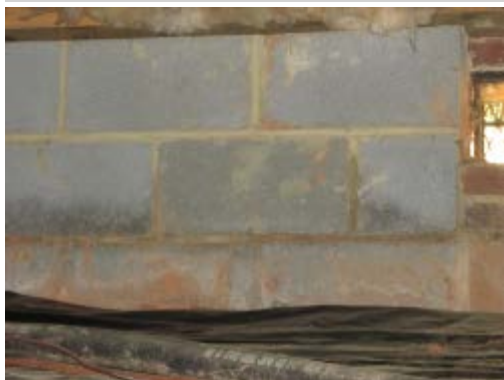
(A1 - 1.2) Main House

Stains and water lines indicate a history of standing water in the crawl space around the perimeter of the foundation and under the porches. Direct water penetration damages the foundation, the wood structure, and creates an undesirable environment in the crawl space areas that encourages insect, fungal growth such as mold/mildew. Repairs are needed to prevent water penetration. Water in the crawl space indicates an absent or damaged waterproofing and foundation drain system. Repairs are needed to prevent water penetration. A general contractor should be consulted for further evaluation to determine the source of the moisture and to make necessary repairs.

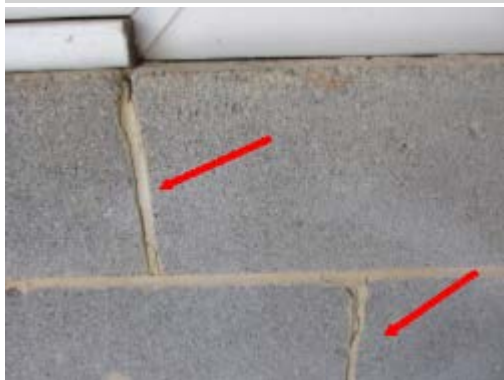
(A1 - 2.1) Garage

Closed cracks were noted in the foundation of the garage at locations where the foundation steps related to elevation change. Cracks in the foundation indicate a deficiency in the foundation, footing, or supporting soil that can change and worsen if it progresses over the life of the home. An engineer should be consulted to determine the significance /cause of the cracks and outline any necessary repairs.

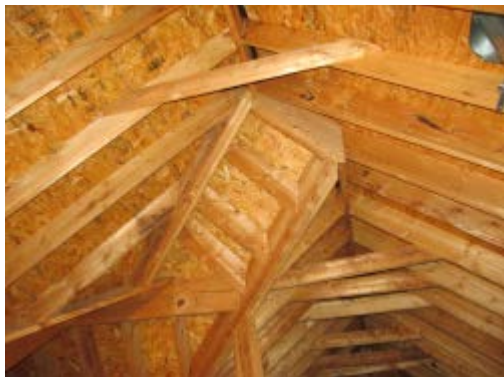
(A6 - 1.1) Main House

From the attic, it was noted that the Valley/Hip rafter located between the main home and first floor room was not posted for end support. End post supports are typically installed to supplement nailed joints and ensure the stability of the roof system. An engineer should be consulted for further evaluation to determine the significance and cause of the concern and outline necessary repairs to ensure the stability of the structure.

From the attic, it was noted that the Valley/Hip rafter located between the main home and first floor room was not posted for end support.

End post supports are typically installed to supplement nailed joints and ensure the stability of the roof system. An engineer should be consulted for further evaluation to determine the significance and cause of the concern and outline necessary repairs to ensure the stability of the structure.

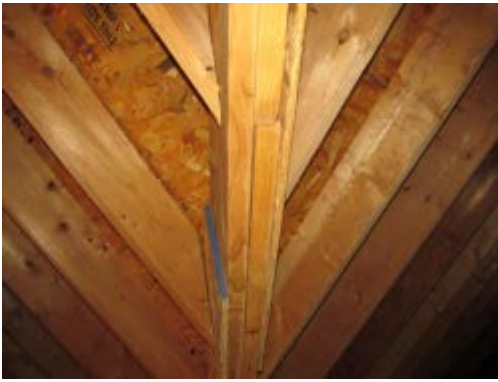
(A6 - 1.2) Main House

From the attic, it was noted that the valley rafter located over the main living room was constructed of multiple members and was not posted for support. Post supports are typically installed to supplement nailed joints and ensure the stability of the roof system. An engineer should be consulted for further evaluation to determine the significance and cause of the concern and outline necessary repairs to ensure the stability of the structure.

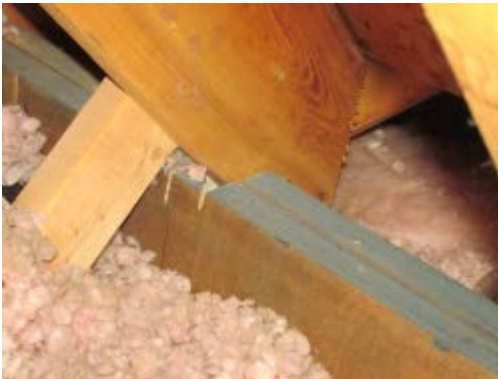
(A6 - 1.3) Main House

The LVL girder located under the main rafters on the front side of the home has been notched for rafter installation. Engineered lumber beams have specific installation specifications that rarely allow notching. If a notch is beyond what would be typically expected and could result in cracking or failure of the beam. A girder is a main structural component that provides support of the framing structure and transfers loads to the foundation. An engineer should be consulted for further evaluation to determine the significance of the concern and outline necessary repairs to ensure the stability of the structure.

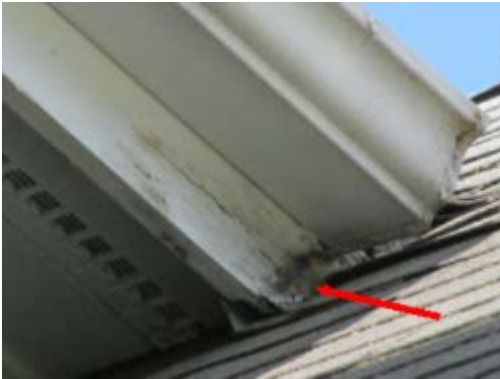
(B1 - 1.1) Main House Front

The exterior boxing of the home need repairs and painting to prevent further damage and water penetration. The following items were noted during the inspection all areas should be evaluated as a repair plan is prepared:

1. Peeling paint, swollen edges behind the gutter trays;
2. Boxing and trim areas were found to have area of decay at roof line intersections

A licensed general contractor should be consulted for a complete evaluation of the trim and boxing to determine the scope of the damage and make necessary repairs.

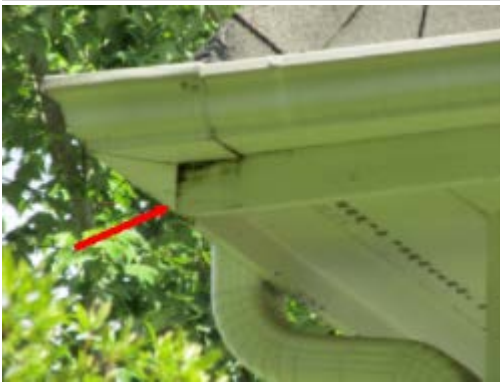
(B1 - 1.2) Main House Front

Additional Photograph: This a photograph of decayed boxing at the left front corner of the main home. All corner trims areas were noted to have some level of decay.

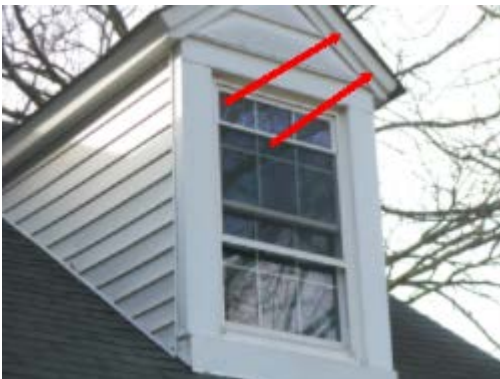
(B1 - 1.3) Main House Front

The trim cladding along the roof rake was not formed to provide a lip to support the shingles and prevent water from traveling behind the trim. A siding installation company or general contractor should be consulted to evaluate and repair the trim to ensure the integrity of the cladding system.

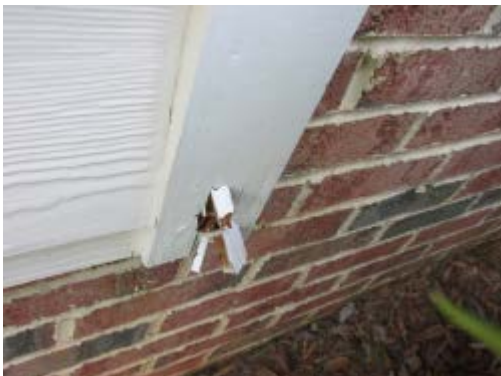
(B1 - 2.1) Main House Rear and Sides

The exterior trim of the home need repairs and painting to prevent further damage and water penetration. The following items were noted during the inspection all areas should be evaluated as a repair plan is prepared:

1. Corner trim moldings have visible areas decay.
2. Vertical wood trim boards at corner and brick intersections have visible areas of decay.

A licensed general contractor should be consulted for a complete evaluation of the exterior trim to determine the scope of the damage and make necessary repairs.

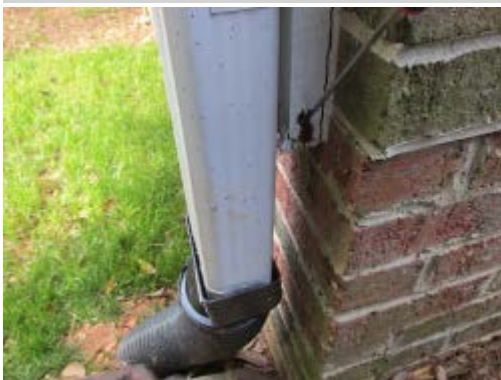
(B1 - 2.2) Main House Rear and Sides

Additional Photograph: This a photograph of a decayed vertical trim molding behind the back left gutter.

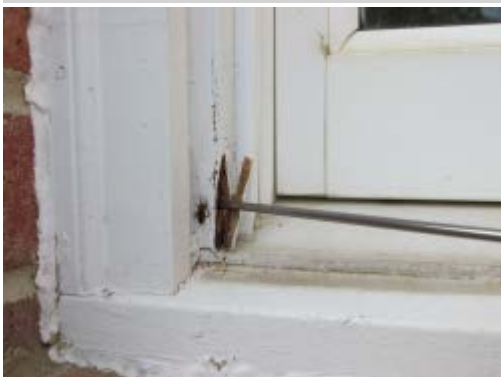
(B2 - 1.1) All Windows

The all windows have soft and decayed wood in the sill, trim, sash areas. Decay in the windows can result in leaking and water penetration and should be repaired as soon as possible. All windows should be inspected for similar damage as repairs are made. A licensed general contractor should be consulted to evaluate the extent of the damage and make necessary repairs.

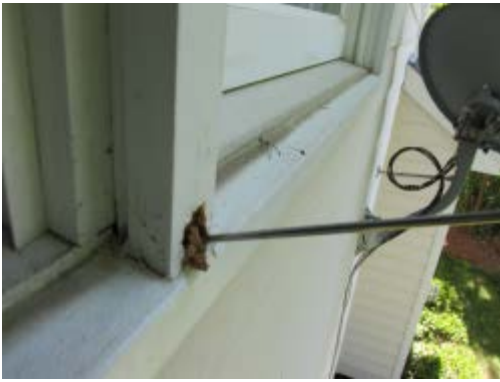
(B2 - 1.2) All Windows

Additional Photograph: This a photograph of the living room window, the trim between the windows is decayed.

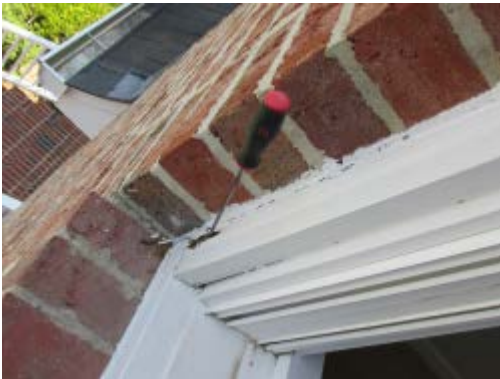
(B2 - 1.3) All Windows

Additional Photograph: This a photograph of a second floor window, decay was noted in all accessible windows.

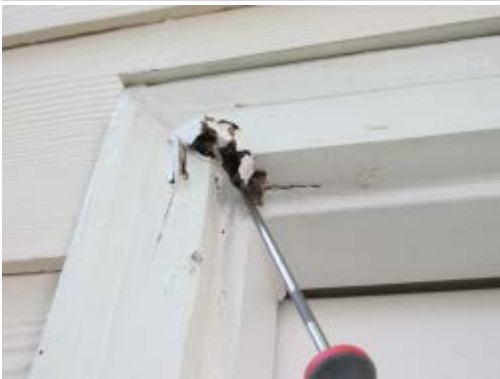
(B2 - 2.1) Door

The door has extensive soft and decayed wood in the frame area .
Decay in the door frames can result in leaking and water penetration and should be repaired as soon as possible. A general repair specialist or licensed general contractor should be consulted for evaluation and repair.

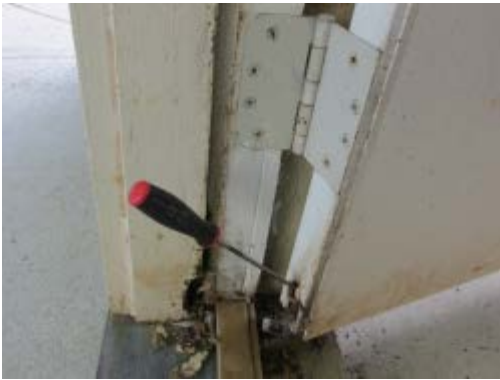
(B2 - 2.2) Door

Additional Photograph: The door also has soft and decayed wood in the door panel area. Decay in the door panel can result in leaking and water penetration and should be repaired as soon as possible. A general repair specialist or licensed general contractor should be consulted for evaluation and repair.

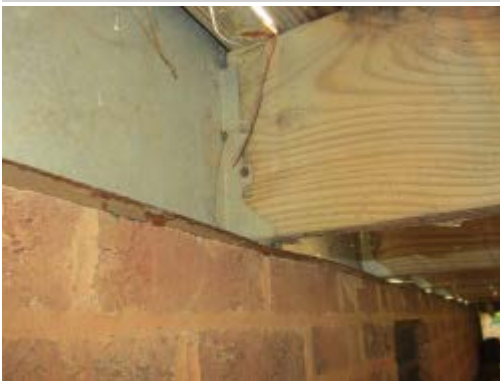
(B3 - 1.1) Deck Sample 1

The metal hangers used to support the floor framing of the deck were installed without the proper number and sized nails. The nail installation is crucial to the function of the hanger, without proper installation the hanger could fail allowing the deck to move or collapse. A licensed general contractor should be consulted for complete evaluation of the deck and to make necessary repairs.

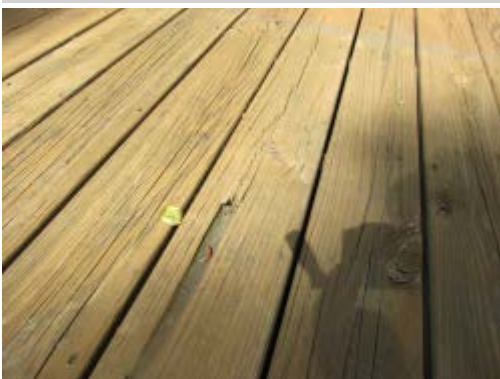
(B3 - 1.2) Deck Sample 1

The wood deck was found to be severely weathered. Decking boards were splintering and cupped. The deck should be considered hazardous. A licensed general contractor should be consulted for complete evaluation of the deck and to make necessary repairs.

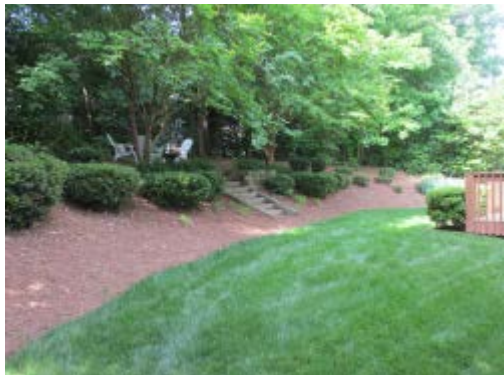
(B5 - 1.1) Grading

The rear yard slopes toward the home and there is evidence of erosion of soil along the sides yards that is directing drainage against the perimeter of the home. Corrections are needed to control drainage and prevent water penetration, a licensed general contractor should be consulted for a complete evaluation and to make necessary repairs.

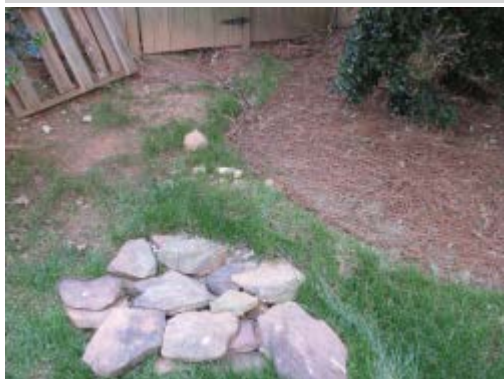
(B5 - 1.2) Grading

Additional Photograph: Evidence suggests that the drainage from the rear section of the lot accumulates along the fence and left foundation wall.

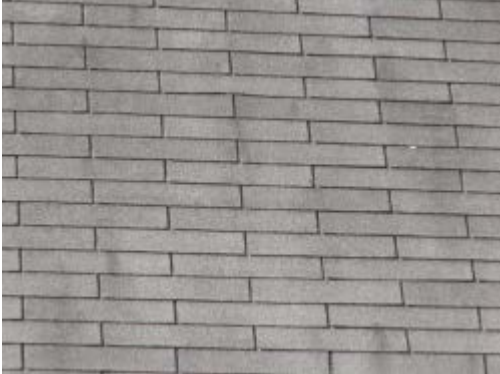
(C1 - 1.1) All Accessible Areas

The roof shingles were noted to be lifting or curling at the corners of the tabs. Since shingles are designed to lay flat to shed water and debris, the curling can result in trapped moisture and leaks. Shingle curl for several reasons including: end of the service life, improper installation and or limited ventilation. A licensed roofing contractor should be consulted for a complete evaluation of the roof covering and flashings system to make necessary repairs to ensure the weathertightness of the roof covering system. At the time of the repair, the roofer may be able to answer questions related to the life expectancy of the roof covering system.

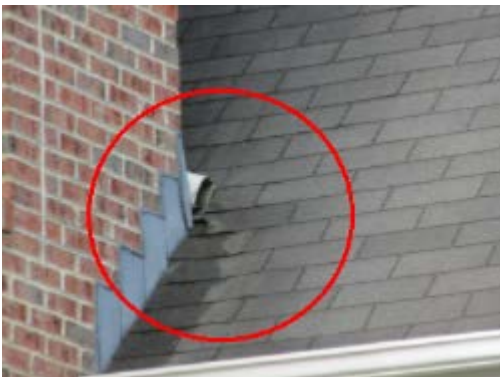
(C2 - 1.1) All Accessible Areas

The gutter downspout at the right dormer is not extended or piped out to direct roof drainage away from the side wall of the main home. Direct drainage from the gutter system can result in direct water penetration into the attic areas of the home. A licensed general contractor should be consulted for a complete evaluation and to make necessary repairs.

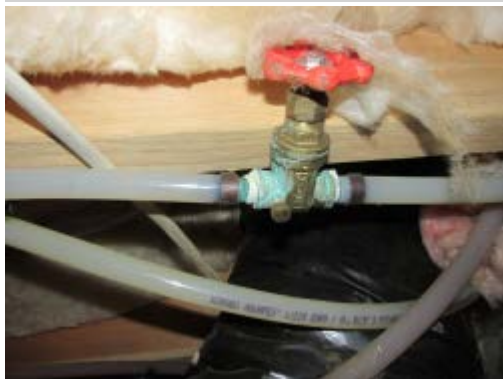
(D1 - 1.1) All Accessible Areas

The main water supply line located in the crawl space at the back door is corroded. Corrosion on the main water lines should be addressed as soon as possible to prevent major leaks and property damage. A licensed plumbing contractor should be consulted for a complete evaluation and repair of the main water supply line.

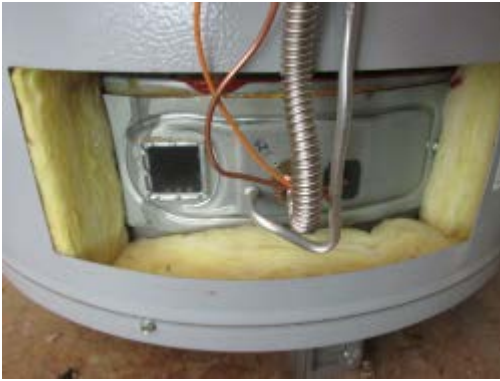
(D3 - 1.1) Unit #1

There was no hot water available for the main home during the inspection. The gas service to the unit was off. The inspector did not have permission or knowledge of the circumstances that required the unit to be turned off and therefore did not turn the unit on. The inspection of the hot water heating unit, fixtures, and appliances was limited and not completed. It is recommended that the hot water be restored and the inspection completed prior to the purchase of the home.

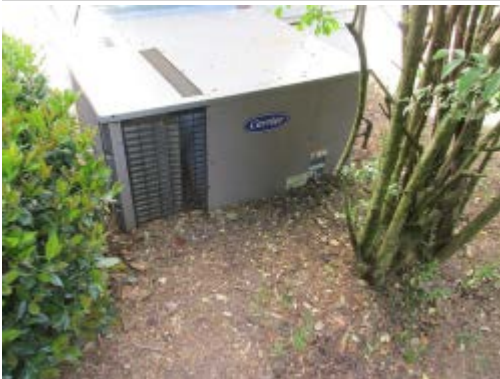
(F1 - 1.1) Heating Unit #1

The grading around the package HVAC unit is directing drainage toward the unit. Evidence suggests that water from lot drainage has been entering the unit., see next photograph. Drainage needs to be corrected to prevent damage to the unit. A licensed general contractor should be consulted for further evaluation and repair.

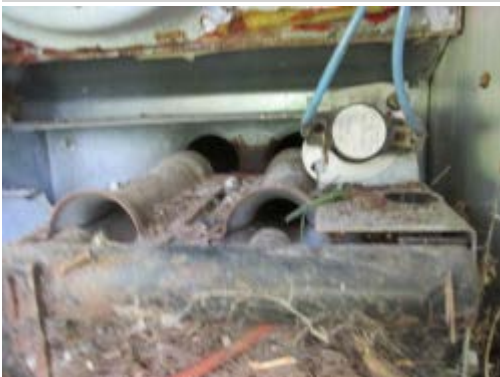
(F1 - 1.2) Heating Unit #1

The gas burner section of the package unit has visible rust and debris in the burner chamber area. The rust indicates deterioration of the exchanger. Deterioration of the heat exchanger is a serious concern that can result in improper combustion and carbon monoxide poisoning. The furnace needs a complete evaluation which should include a heat exchanger inspection to ensure safe, reliable, and proper operation of the HVAC system. A licensed HVAC contractor should be consulted for repair.

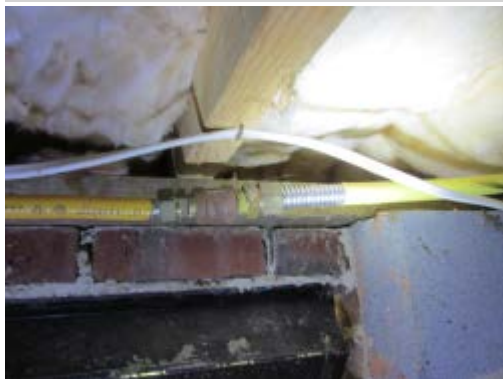
(F3 - 1.1) Crawl Space

This home has corrugated stainless steel gas lines. This gas line has specific installation requirements related to required bending allowances, support, protection, and electrical bonding to ensure safe conditions. The electrical bonding is typically required to prevent damage from electrical storms in the event of a lightning strike. During the home inspection the bonding attachment could not be located. An electrical contractor should be consulted for a complete evaluation of the CSST installation and to verify the presence of electrical bonding.

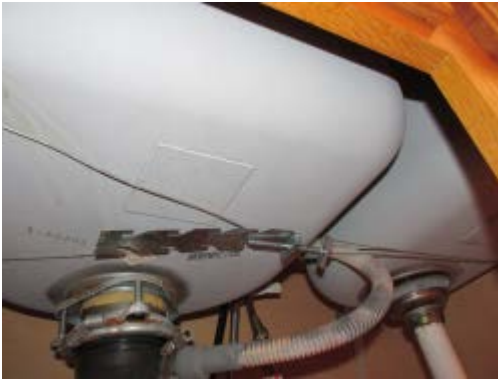
(H2 - 1.1) Kitchen

The sink is in need of further evaluation and repair. The following concerns were noted at the time of the inspection:

1. The sink is supported by a wire and bracket was not secure. A general repair specialist or licensed general contractor should be consulted for evaluation and repair.

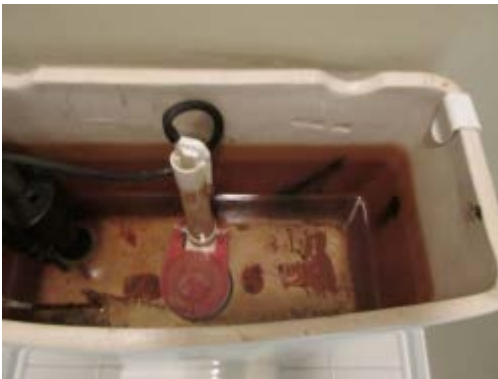
(H3 - 1.1) Bathroom #1 Master

The toilet flush valve is not operating properly. This could result in improper functioning, flooding and waste of water. A licensed plumbing contractor should be consulted for evaluation and repair.

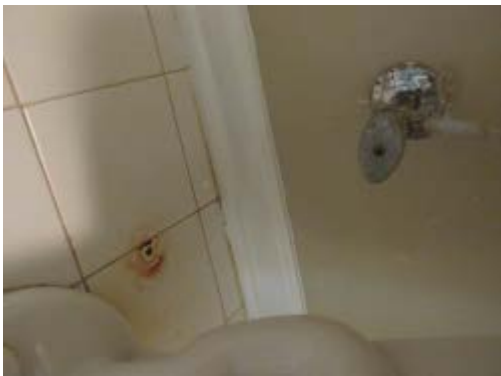
(H3 - 2.1) Bathroom #2

The floor area under the toilet tank has a rust stain indicating a history of a leak or a seeping leak at the tank bolts or water turn off. The toilet tank bolts/gaskets and the turn off valve need to be evaluated by a plumber to ensure that they are not leaking. A licensed plumbing contractor should be consulted for evaluation and repair.

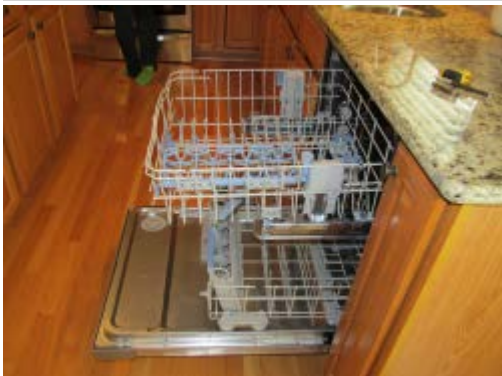
(J1 - 1.1) Dishwasher

The dishwasher is not secure to the cabinet and it moves forward when the door is opened. The appliance needs to be secured to the cabinet to prevent damage to the unit or personal injury. An appliance repair person or general contractor should be consulted for repair.
